Spittal, Thurso

Phase 2 Ground Investigation Report

Curtins Ref: 085447-CUR-XX-XX-T-GE-00002

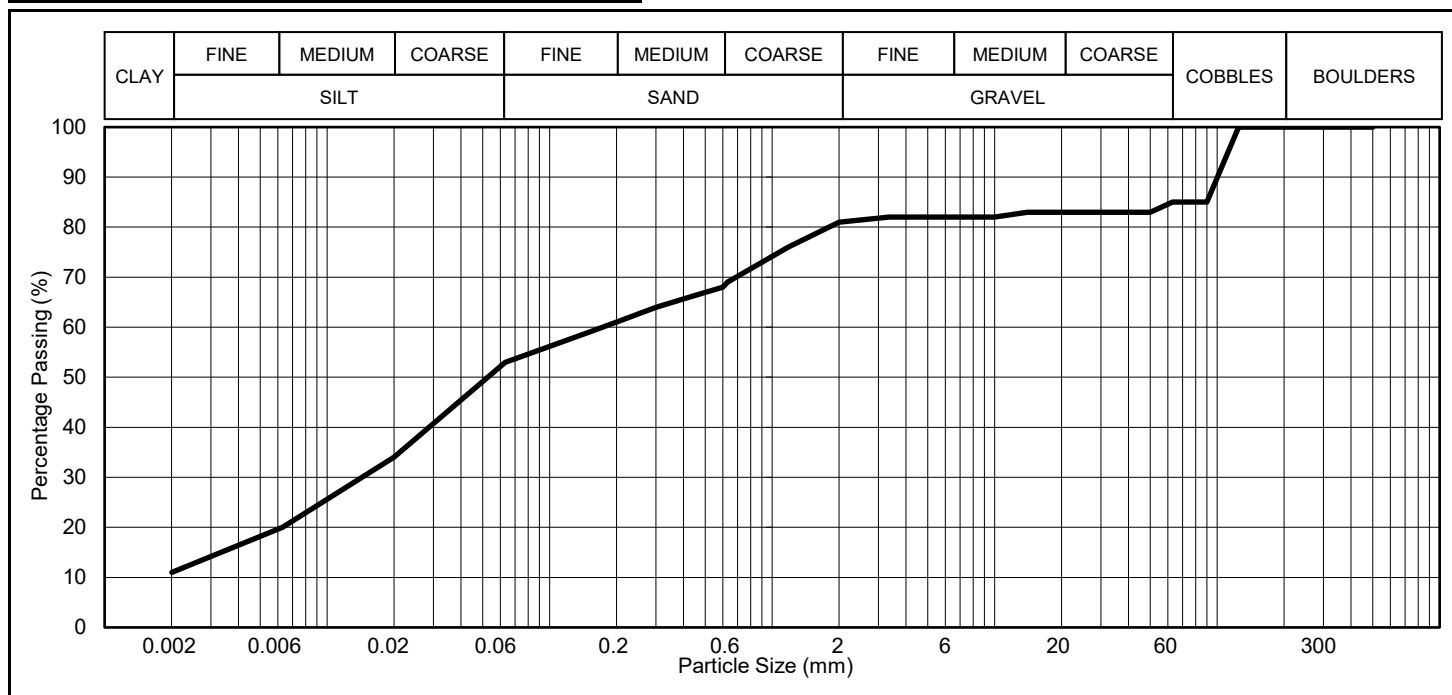
Borehole	TP08
Sample	B
Depth (m)	0.50

SIEVING				SEDIMENTATION (Assumed ps of 2.65Mg/m³)				
Sieve Size (mm)	Percentage Passing (%)	Specification		Particle Size (mm)	Percentage Passing (%)			
		Not Applicable						
		Lower %	Upper %

500.0	100	-	-	0.0200	34			
300.0	100	-	-	0.0063	20			
125.0	100	-	-	0.0020	11			
90.0	85	-	-	GRADING CLASSIFICATION (SHW TABLE 6/2)				
75.0	85	-	-					
63.0	85	-	-

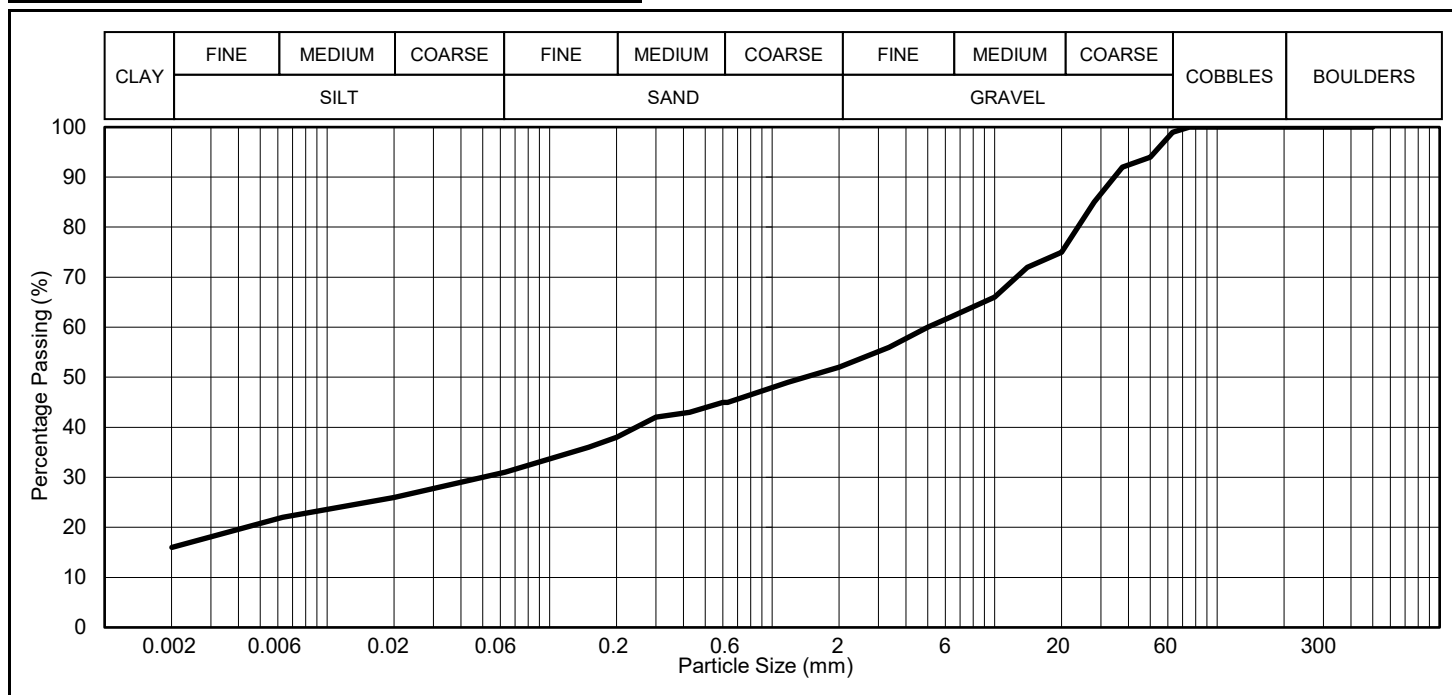
Borehole	TP12
Sample	B
Depth (m)	0.50

SIEVING				SEDIMENTATION (Assumed ps of 2.65Mg/m³)				
Sieve Size (mm)	Percentage Passing (%)	Specification		Particle Size (mm)	Percentage Passing (%)			
		Not Applicable						
		Lower %	Upper %

500.0	100	-	-	0.0200	26			
300.0	100	-	-	0.0063	22			
125.0	100	-	-	0.0020	16			
90.0	100	-	-	GRADING CLASSIFICATION (SHW TABLE 6/2)				
75.0	100	-	-					
63.0	99	-	-
